Pilton church has recently had extensive work carried out to its roofs which involved erecting scaffolding to enable the timbers to be treated. This gave an opportunity to examine the roof during the works which resulted in a number of new discoveries being made. This report gives an overview of the roofs and illustrates some of the carvings that were found.

Pilton is very fortunate in retaining historic timber roofs to the porch, nave, north aisle and chancel which still retain their historic form and date from the fifteenth century. The porch has a collar beam roof carried on stone corbels with wooden carvings and bosses, the nave and north aisle both have tie beam roofs with vertical post carried on stone corbels, spandrels, decorated wall plates and tie beams with attached angel bust and open tracery within the trusses, the chancel has a panelled roof with carved foliage at the intersections and angel with large outstretched wings along the wall plates.

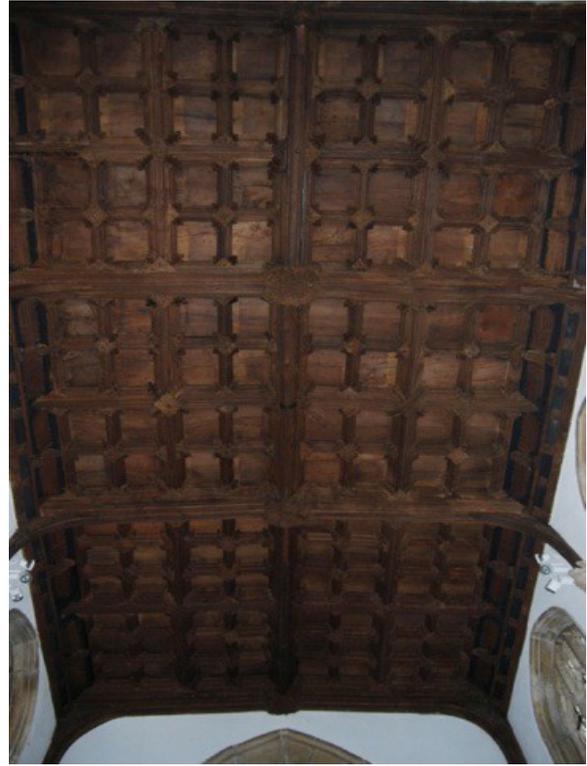
Fig. 2 Chancel roof

The roof of the chancel is slightly later in date and is of panelled construction, it is divided into a six sections divided by moulded beams with carved foliage at the intersections which are sub divided into a further four sections. Wall shafts rise up from stone angel corbels to support the main cross beams of the roof whilst around the wall plate are angels with wide outstretched wings. Figs. 31 to 32 show the main construction of the roof with its foliage decoration whilst Fig. 33 shows a foliage boss. Figs. 34 to 37 show the angels around the wall plate which appear to be largely contemporary with the roof, note the different positions of the wings on some angels which may indicate later alterations.

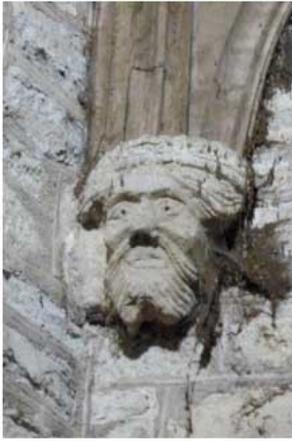
Fig 3 King corbel

The first illustrations show the porch roof which although restored is basically medieval, it has a number of interesting features that can be easily seen from ground level. It has six stone corbels which support the wooden roof, on the east side are a king with a crown and beard (Fig. 2), an angel holding a shield who wears a topknot on her head (Fig.3) and a man with a beard, long hair and hat (Fig. 4) whilst on the west side are a lady (Fig. 5), an angel holding a shield (Fig. 6) and a queen with a large crown, long neck and prominent shoulder; the line of her upper clothing is just visible as a thin line (Fig. 7). In the centre of the roof is a wooden boss showing the head of a bearded man with staring eyes and large teeth with foliage carved around the top of his head (Fig. 8). The wall plates are decorated with small rectangular shaped foliage and have crenellated tops.

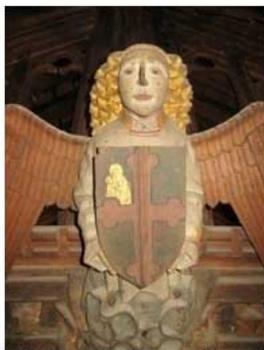
Fig 11 Angel with Virgin and Child

The roofs of the nave and north aisle are low pitched and are of a type frequently found in Somerset; they both have six bays but that to the north aisle is much narrower. When originally constructed they would probably been brightly painted as seen at St Cuthbert's church, Wells and Evercreech church but the only colour remaining is on the nave roof nearest to the chancel arch. This may however be because the section of roof nearest the rood screen was often more highly ornamented and is known as the ceillure. The painted angels hold shields and stand on clouds, they appear to be feminine with long flowing locks painted yellow and are dressed in white surplices with gold collars and cuffs lined in red, all have red painted lips and black irises to the eyes; the wings are mostly replacements. The illustrations show details of these painted angels, that on the first tie beam west of the chancel arch has a red cross with trefoil ends on a black background, in the top left hand quadrant is a gold painted Virgin holding the Christ child (Fig. 11), on the east side of the tie beam is an angel holding a shield with a red cross painted on a red background (Fig. 12), on the north side of the easternmost bay is an angel holding a black shield with a crucifixion cross placed on a green painted hill around which are red tear drops, the cross has a long spear on the left hand side and a long handled sponge on the right side (Fig. 13). On the south side of the east bay is an angel holding a shield with a green Crown of Thorns painted on a red background (Fig. 14), the angel on the tie beam over the chancel arch holds a black painted shield also painted with red tear drops which has a ladder placed on the left side with a classical column on the right and a whip laid across its centre (Fig. 15). Fig. 16 is another view of the angel in Fig. 12 showing the large

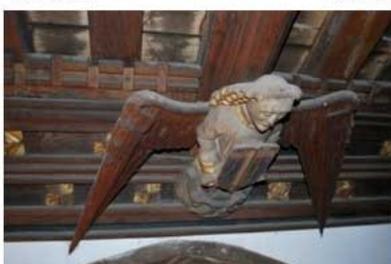
Fig 18 Angel (side view)

foliage boss located below it, these are painted gold in the easternmost bay of the nave roof, note also the small gold painted foliage carvings that also decorate the timbers at the eastern end of the nave roof. Within the corners of the roof at the east end are elongated foliage carvings painted gold with further foliage within the spandrel below that retain traces of red paint between the foliage (Fig. 17). Fig. 18 shows a side view of the painted angels and Fig. 19 illustrates a replacement angel to enable comparison to be made with the medieval originals.

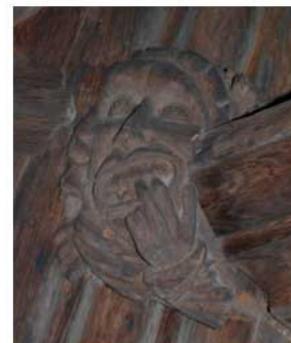
Fig 20 Head at West end of Nave Roof

In addition to the painted angels, a number of other carvings are located on the nave roof timbers which are difficult to see from the ground, at the west end in the centre is a man's head with large eyes and grinning toothed mouth (Fig. 20) whilst on a rafter above the open work tracery filling the truss west of the painted angels is a man's head (Fig. 21) with two faces joined together one of which has a hand in its open toothed mouth which may indicate that he has tooth ache, the main head wears a medieval type hat with a curled cut brim.

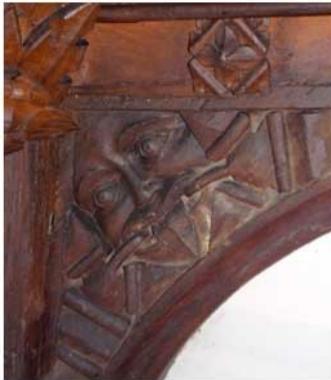
Fig 22 Green Man

The roof to the north aisle are unpainted but has a number of carvings on the rafters and spandrels which are difficult to see from the ground together with other variations not found on the nave roof. The most visible carvings are located on the spandrels of the roof and include a 'green man' with a protruding tongue and foliage emerging from his mouth (Fig.22), an upside down angel with a bulging tummy and long fingers (Fig. 23) and foliage

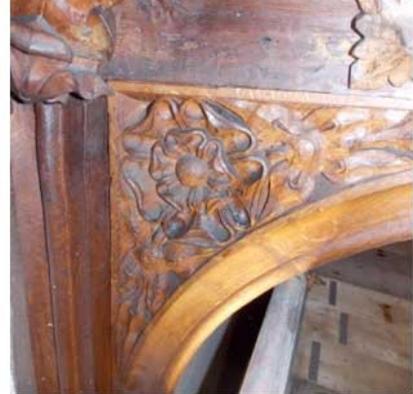
Fig 24 Tudor Rose

such as the 'Tudor' rose in Fig. 24. Hidden in the rafters are other carvings such as a smiling face with foliage around its head (Fig. 25) a head with bulging eyes, toothed mouth and twisted moustache (Fig. 26) and an owl (Fig. 27) which may be relatively modern. The angels appear to be replacements as shown in (Figs. 28 & 29) but have been well carved; they include one playing the bagpipes that may be medieval (Fig. 30),

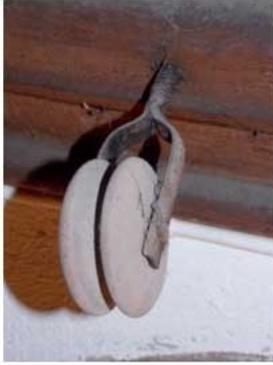
Fig 38 Pulley

A number of ceramic pulley wheels (Fig. 38) were found attached to the wall under the roof which these may have been put in place during the World War II to enable blinds to be pulled up providing a blackout in the church during services.

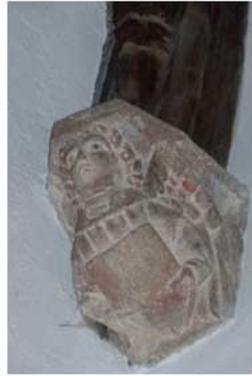
Fig 39 Angel Corbel

Another important feature of the roofs which should be noted are the stone corbels, these are mostly of a standard type with angels holding up shields or books (Fig. 39) but other variations exist including an angel holding a cloth in the chancel (Fig. 40) and one with original writing painted on the shield in the north aisle (Fig. 41).
